TWR-17543-1

# **Flight Motor Set 360T004 (STS-30R) Final Report**

**Volume I  
(System Overview)  
September 1989**

***Thiokol* CORPORATION**  
**SPACE OPERATIONS**

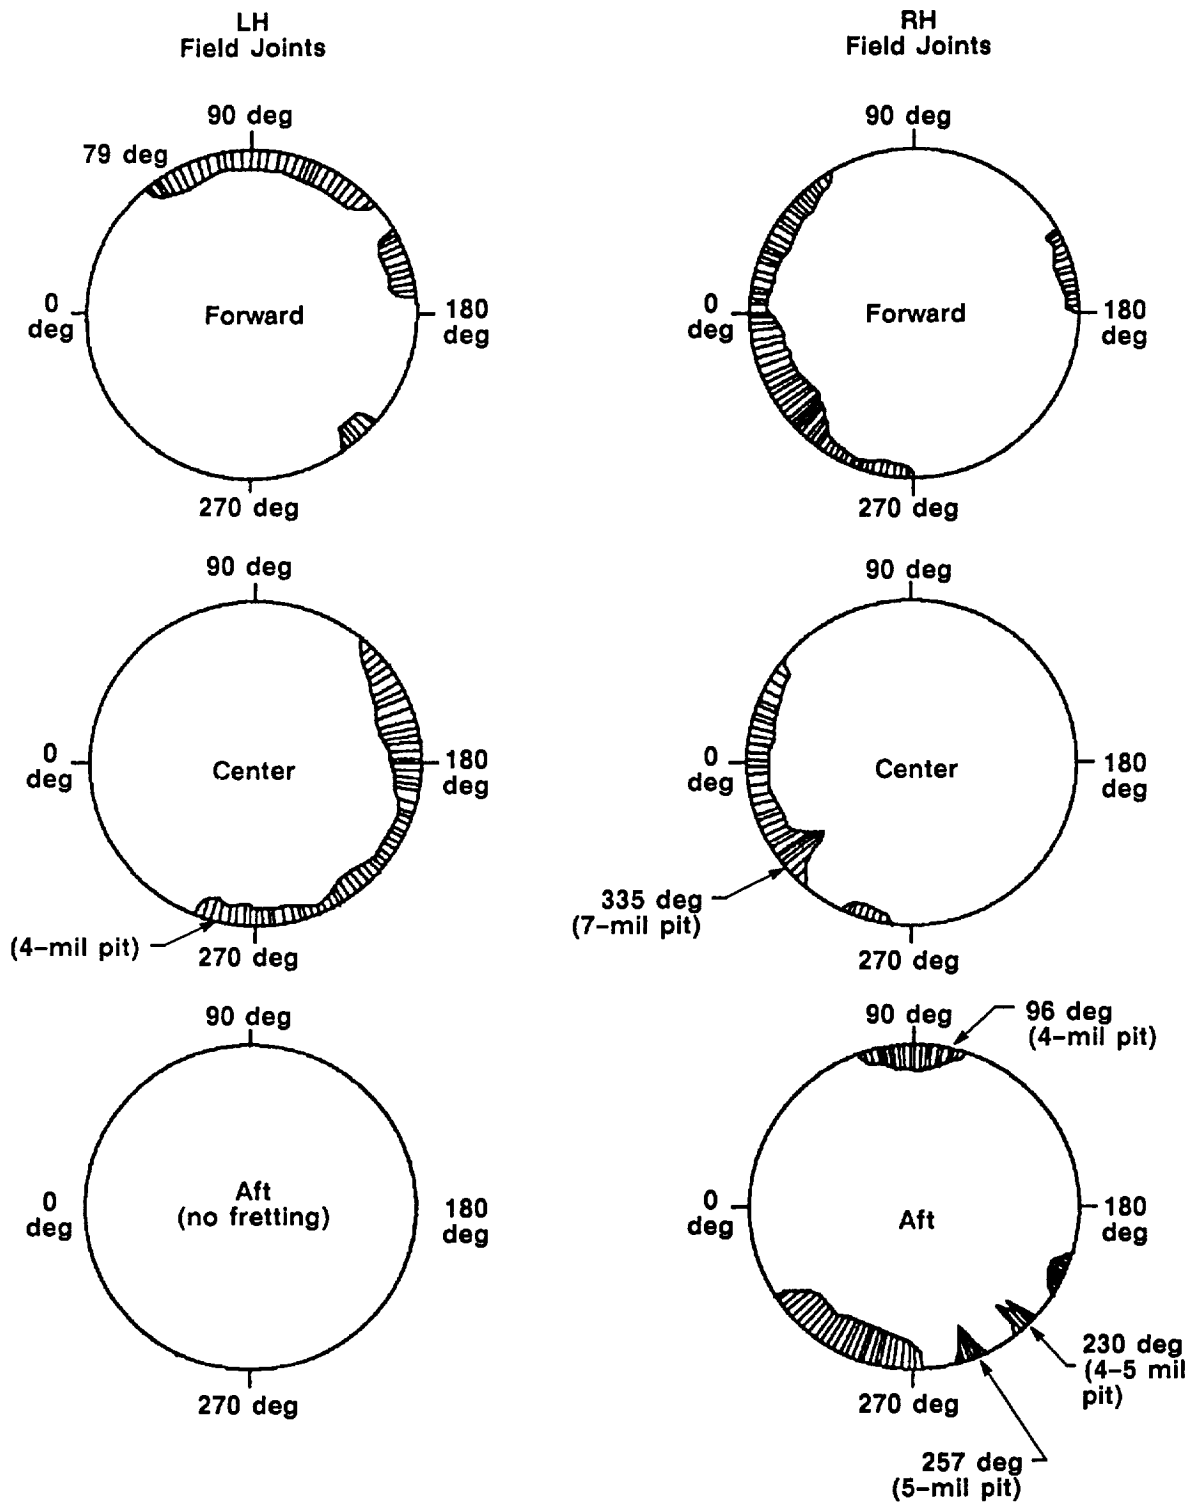
3.1.9.2 Case. Overall, this flight exhibited fretting of a lesser magnitude than 360L003 (STS-29), although fretting was observed on five of the six field joints. The deepest pit measured was 0.007 inch.

Note: Line length indicates relative severity of observed fretting
